EXPERIMENTAL PLANT FOR RESOURCE RECOVERY

REPORT ON PLANT OPERATIONS

APRIL, 1978 - SEPTEMBER, 1979

Waste Management Branch

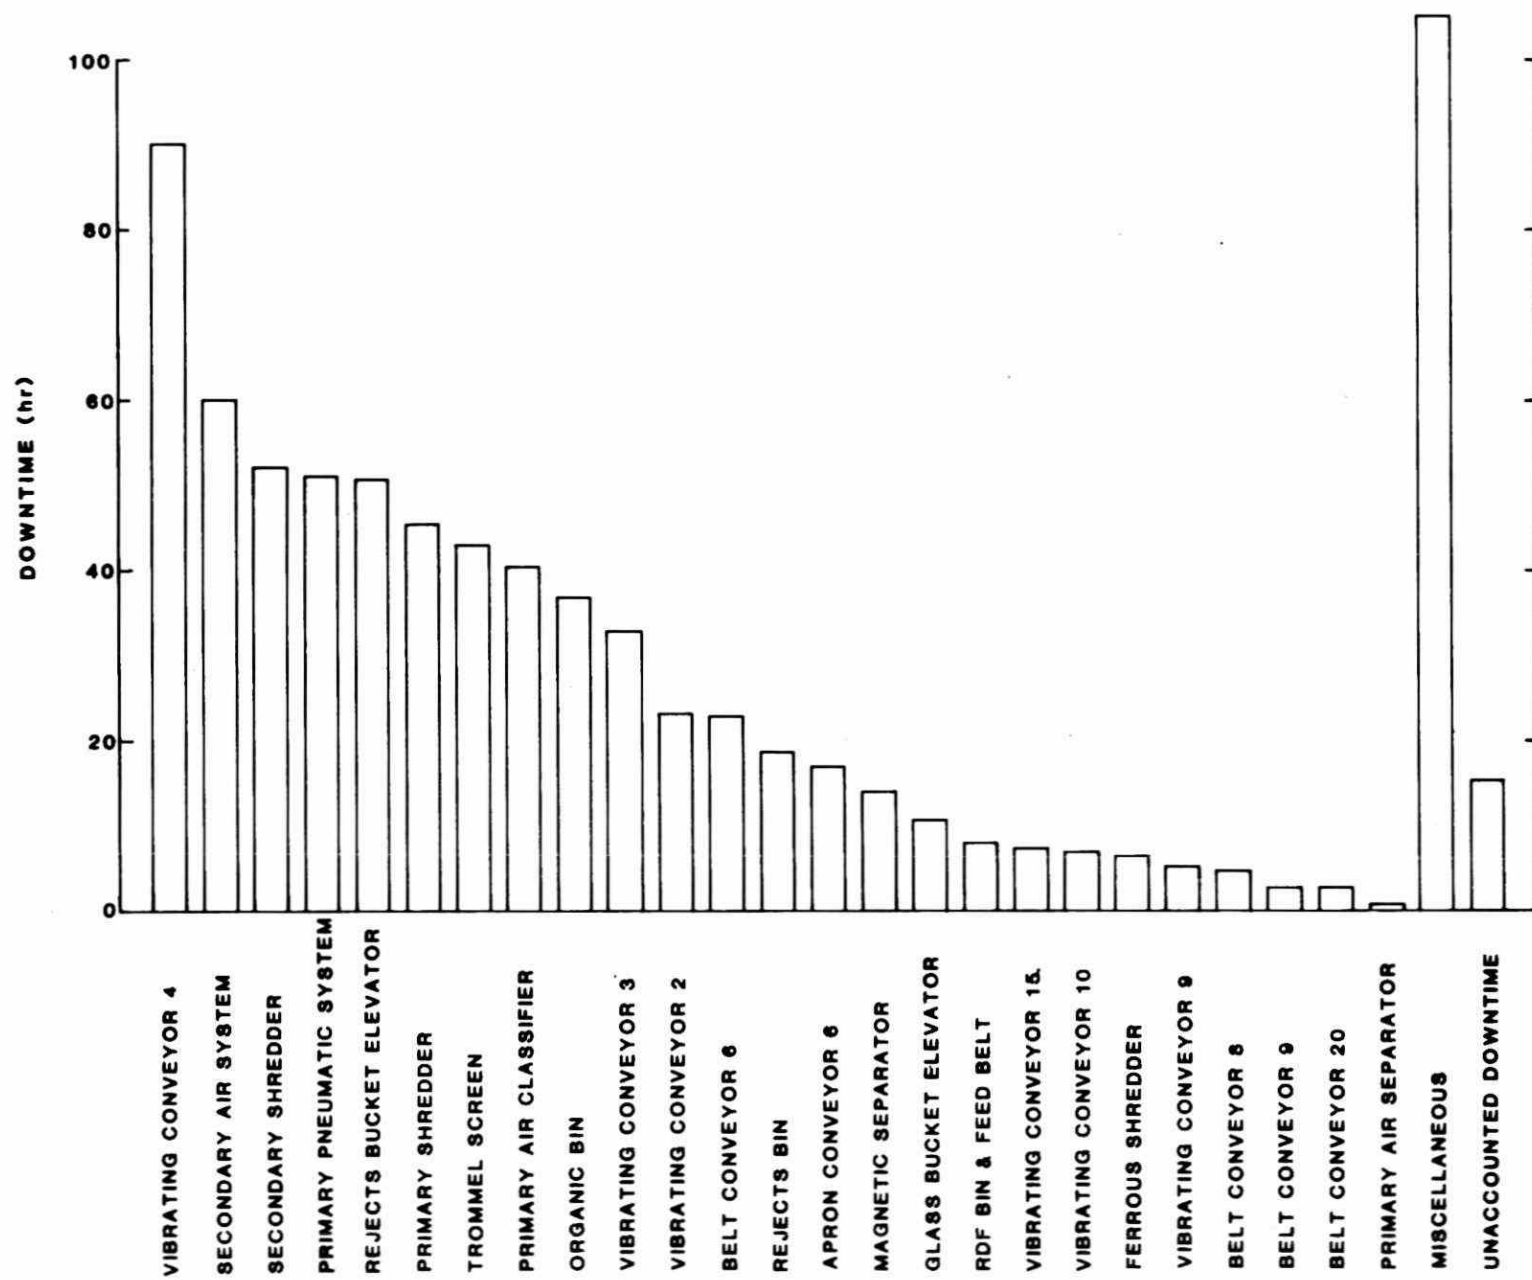
Fig. 6 - Equipment Downtime

In considering downtime recorded during operating hours, problems associated with the primary shredder discharge conveyor accounted for the most downtime (90.6 hours). As indicated earlier, these problems resulted from the inability of the vibrating conveyor to move material reliably, frequently resulting in material jams that required considerable time to free the compacted material. Because of the cost and downtime that would be associated with replacement of this conveyor, attempts were made to minimize downtime by

changes to operating procedures and adjacent pieces of equipment rather than undertaking replacement of the conveyor.

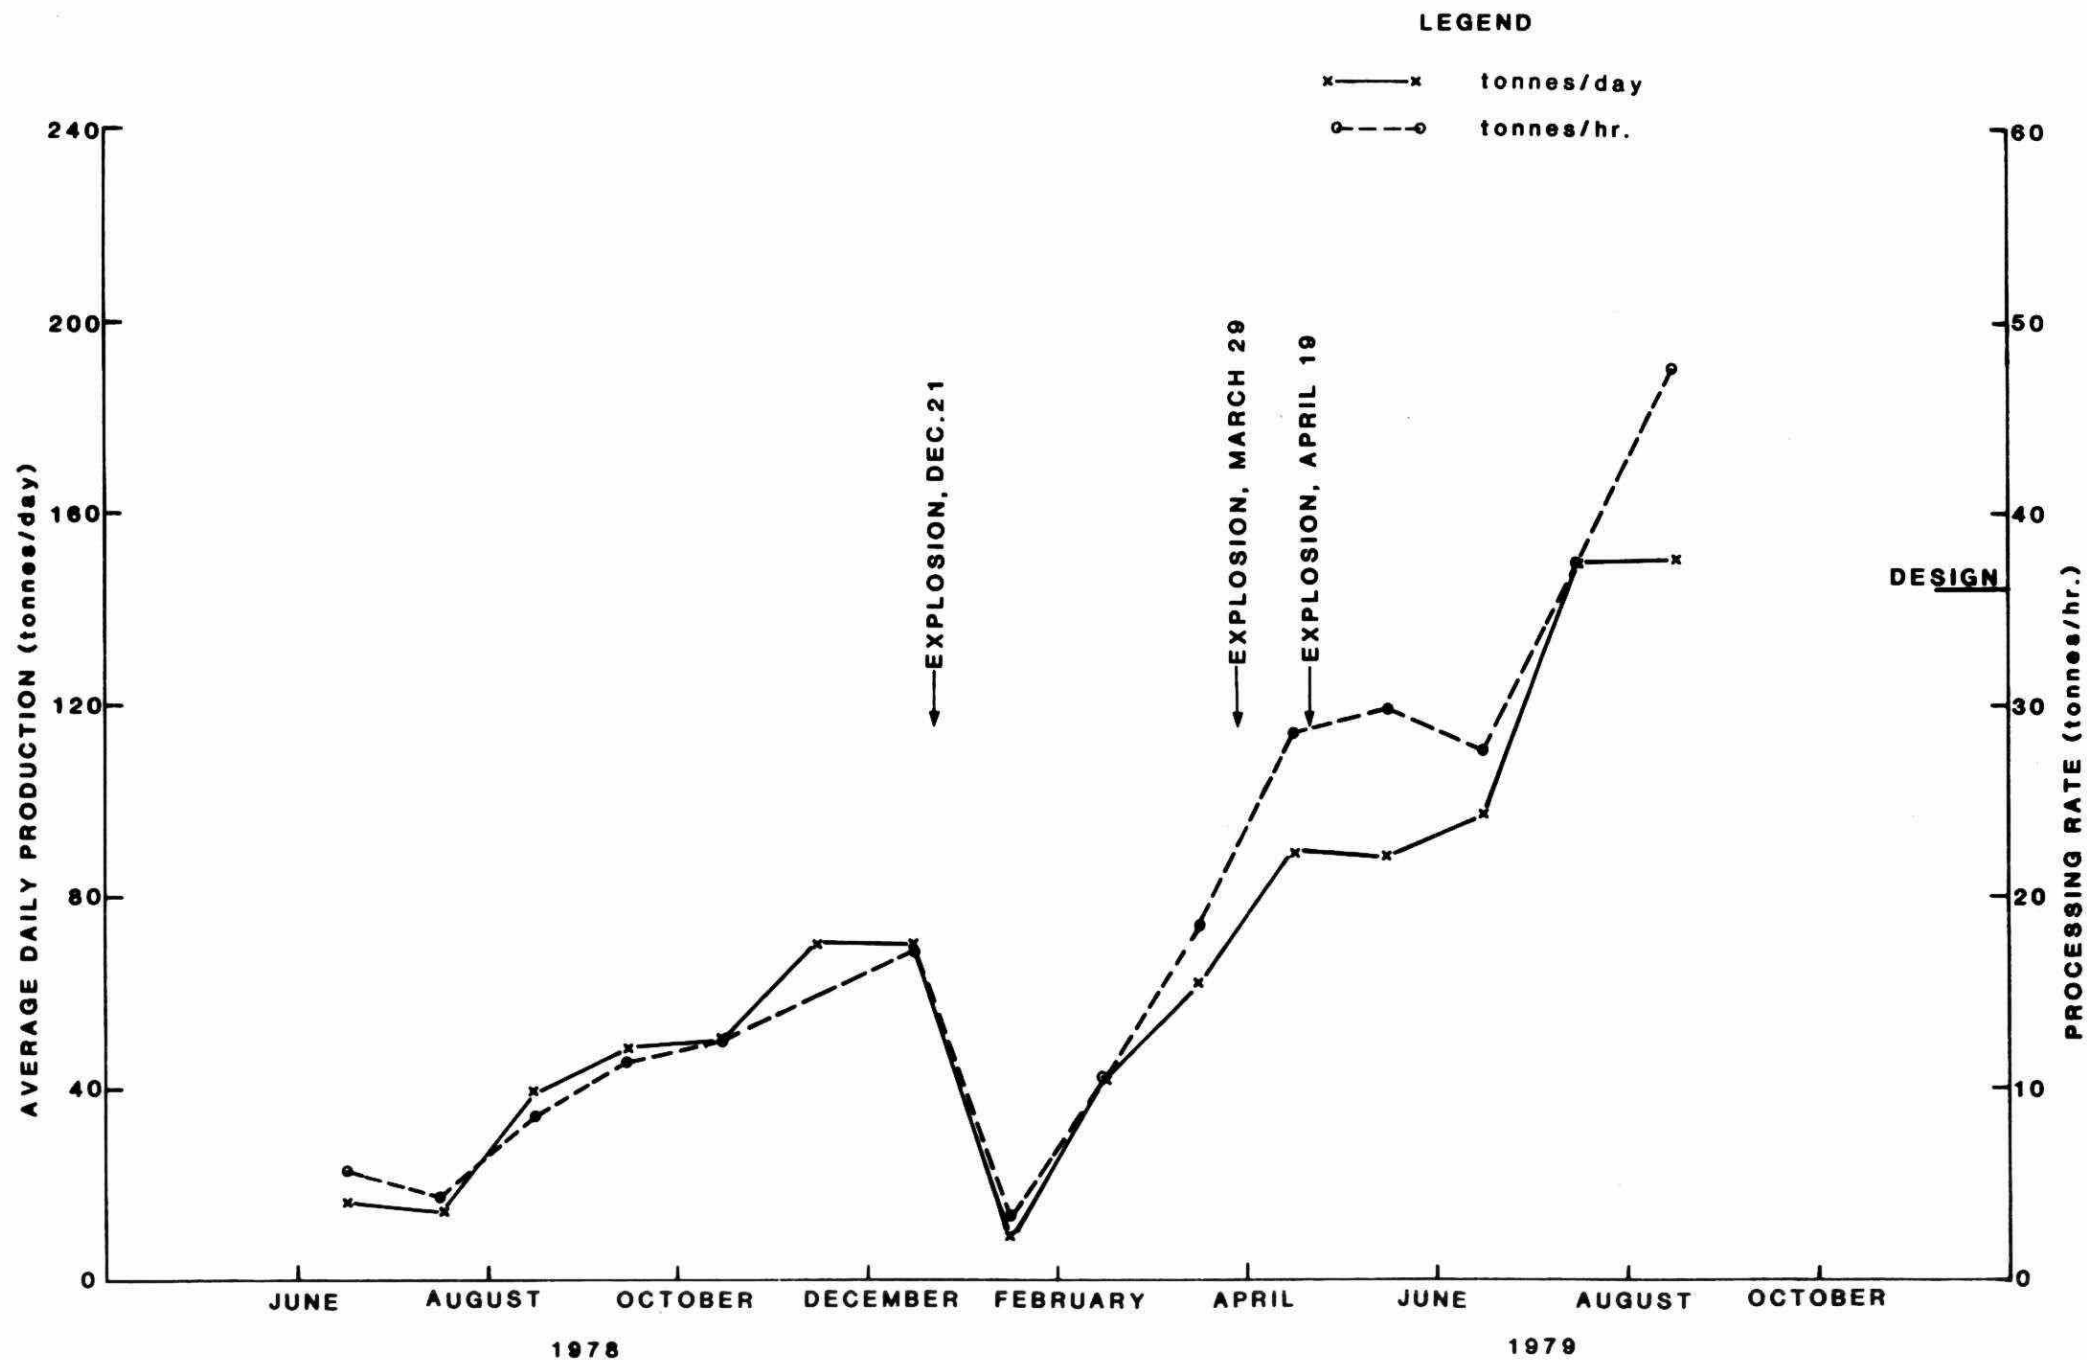
Fig. 7 - Production Performance

The progress in production performance over the period of this report is shown in Figure 7. In this figure, gross production correlated well with the processing rate during initial shake-down and start-up. However, later on a marked increase in the processing rate did not result in a similar increase in daily tonnage processed. Obviously, when the production processing rate was increased either new problems arose or existing problems intensified. Another restraining factor in attaining acceptable processing rates and daily process tonnages was the three major explosions encountered in the primary shredder area. As shown in Figure 7, little gain or even losses were experienced in processing productivity immediately following the explosions in December, 1978 and March and April, 1979.

The design processing rate of the resource recovery system was 36 tonnes/hour, a rate that was obtained both in July and August, 1979. However, it should be recognized that the nature of resource recovery processing facilities do not allow extrapolation of the basic design processing rate over an entire 8 hour working shift. It is generally felt throughout the industry that a processing availability of approximately 80% is likely to be the maximum attainable. A realistic daily process tonnage for this particular plant is then approximately 230 tonnes/day. This design production figure was only exceeded once during the period of this report.
